DESIGN GUIDELINES FOR HISTORIC PROPERTIES

CITY OF LAKELAND

Adopted (12/17/2020)

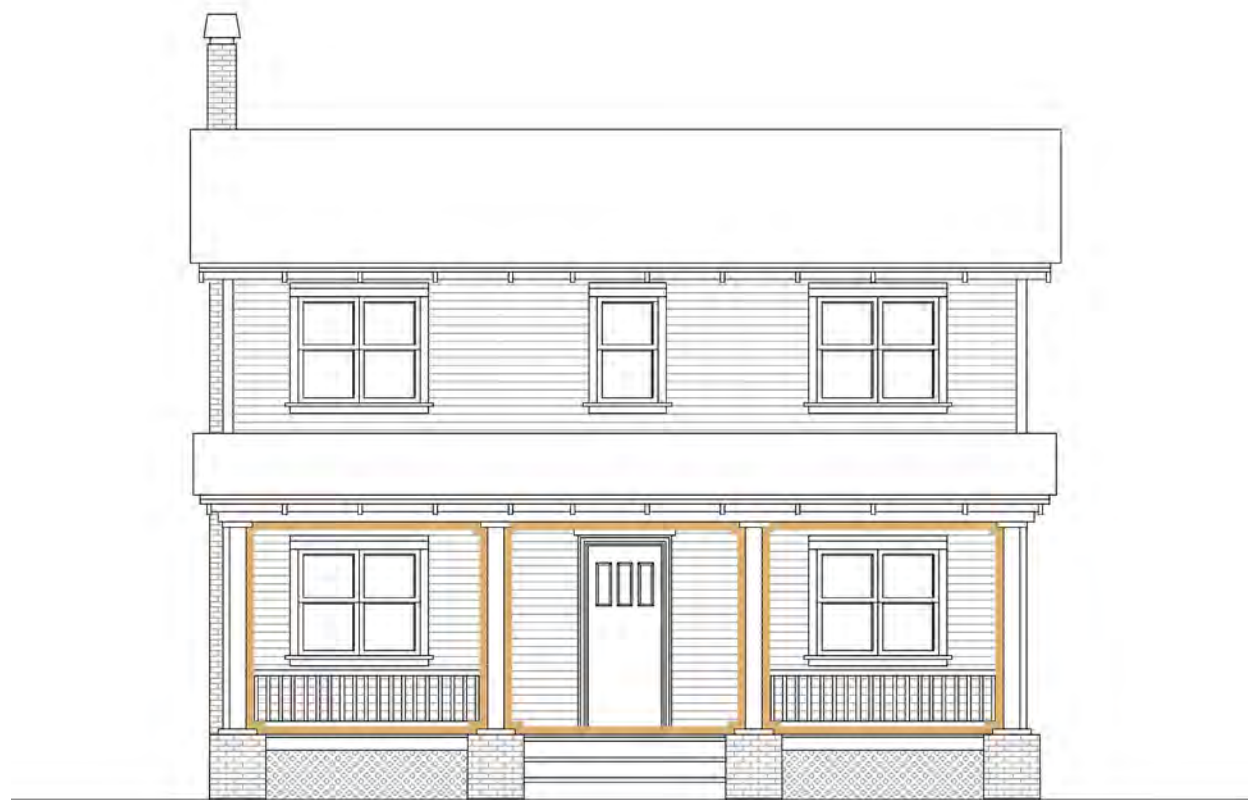
Figure 4.18: *Regular Arrangement of Porch Columns and Wall Openings*

The way columns are placed on a porch, fenestration patterns of windows and doors and other façade features defines the structure's perceived rhythm and order from the street. This layered condition, which often defines symmetrical facade conditions, is also one of the most prominent visual compositions that expresses a unique architectural style. New infill structures and porch additions should interpret these as precedent conditions and reflect porch column and fenestration patterns that work in conjunction with each other as major façade compositions.

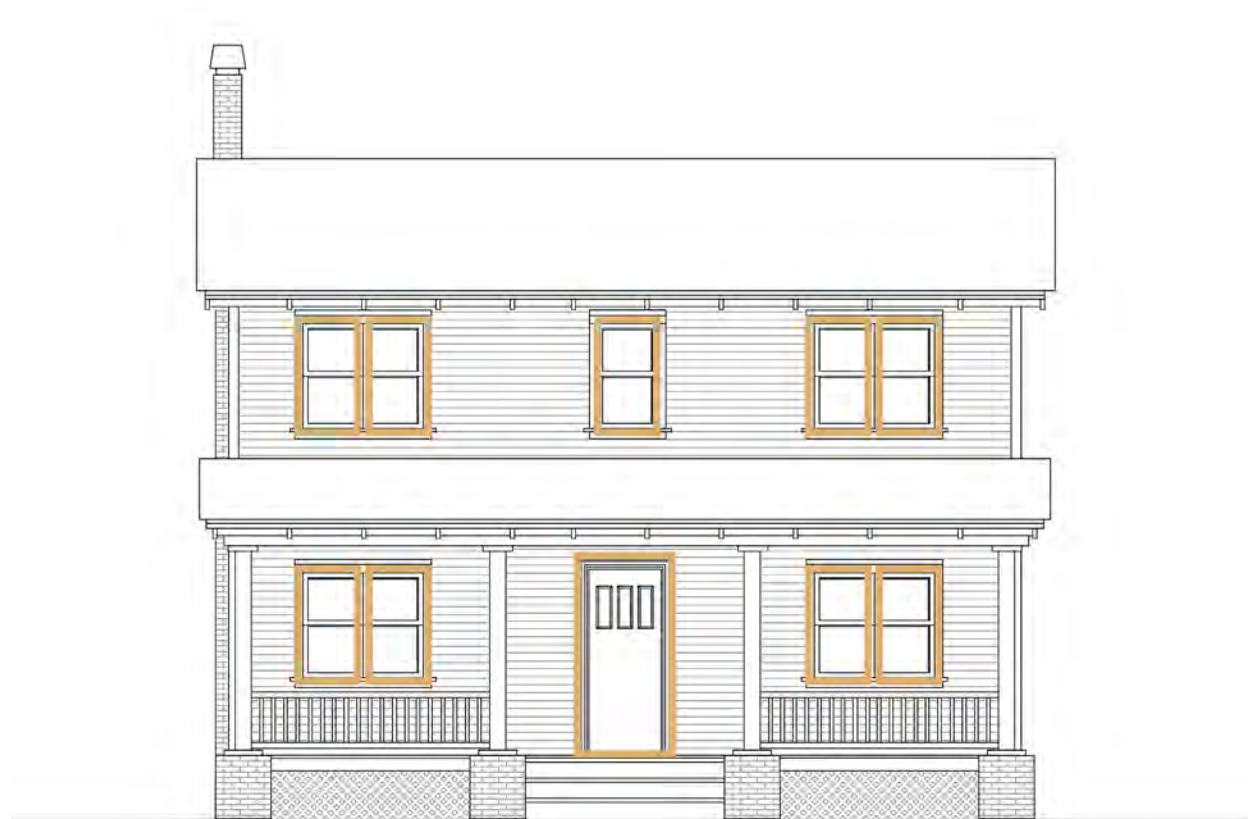
Figure 4.20: *Acceptable Window Configurations*

trim features. Windows should be configured vertically or square with height to width proportions ranging from 1:1 to 3:1. These proportions are often based on the human body and reflect the window patterns of adjacent historic structures. The many window options available today are primarily constructed of wood, clad-wood or a synthetic material such as vinyl. Regardless of materials used, windows in new infill structures that use traditional design features, should be indiscernible from wood windows at about four feet away.

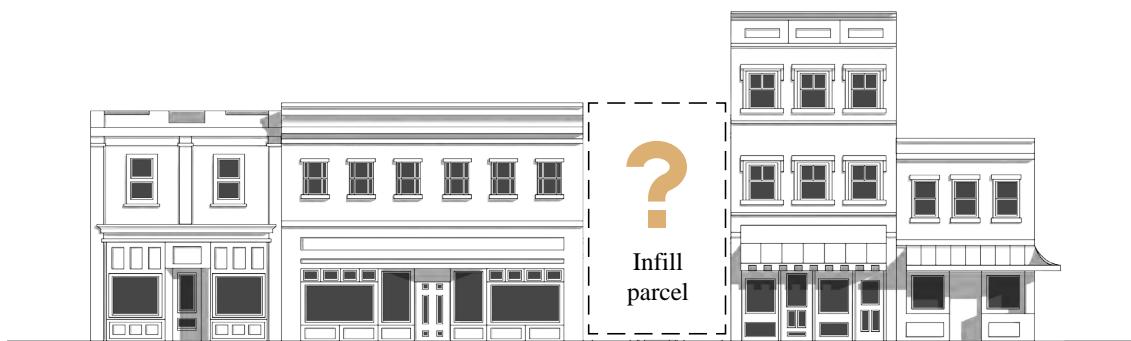
Figure 4.43: *Commercial Infill Conditions*

Infill development in commercial areas should be well-suited to historic contexts and should incorporate construction methods that relate to the current time period. While existing historic structures can serve as inspiration for new infill development, these Guidelines do not require a direct replication of existing historic buildings. Doing so creates a false sense of historicism and may in fact detract from the authentic character that already exists. However, with the construction of buildings over three stories in height, historic buildings over three stories in height should be referenced in designing new, taller structures.

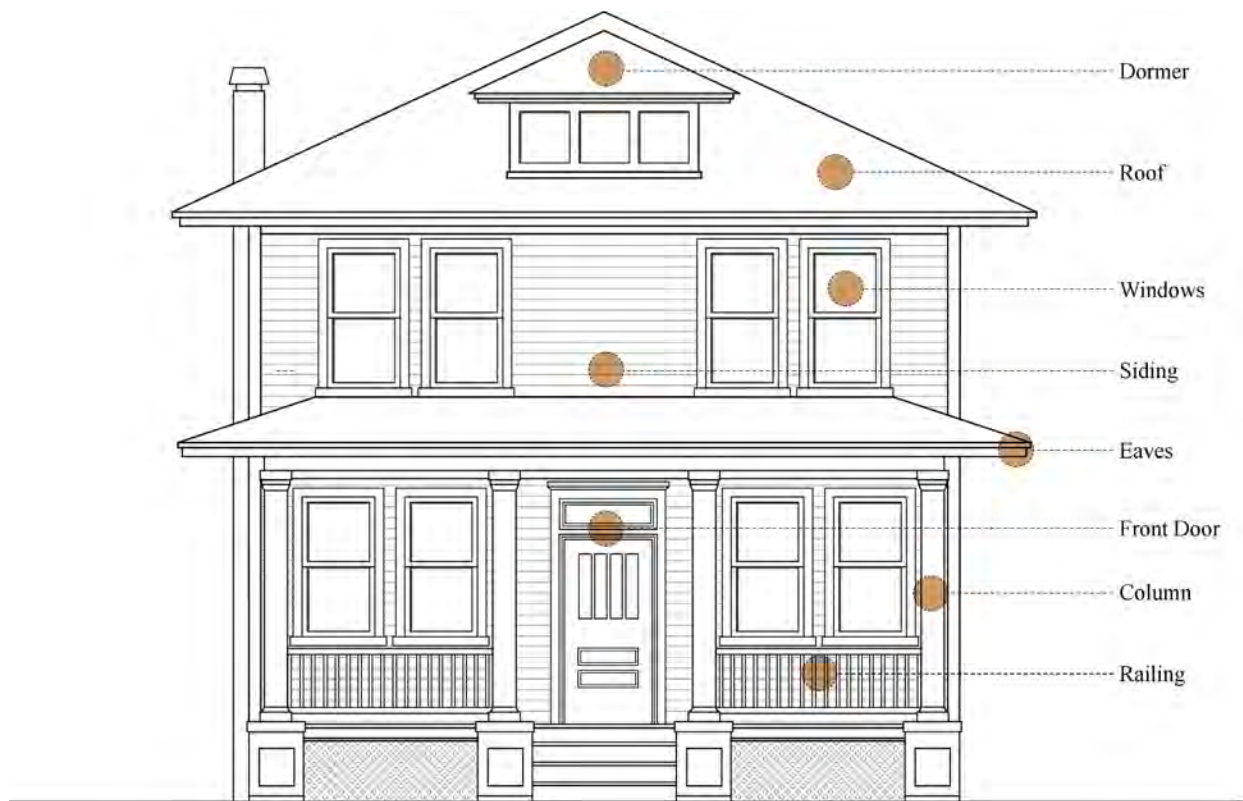
Figure 5.18: Four Square Facade Features

and for protection from high water. The Four Square has a symmetrical façade, sometimes with an offset porch. The porch is always accessed by wide entry stairs and runs the full width of the house with classical, rectangular columns under a hipped-roof with wide overhangs. The exterior can be found in many different materials and sometimes in combination of horizontal wood siding, brick, stone, stucco, shingle, clapboard siding. The house features simple, double-hung, often irregularly shaped windows with a sheet of plain glass for the lower portion and, a grouping of smaller panes united in a single frame divided by thin mullions for the upper portion. The roof configuration of the typical Four Square house is a combination of hipped planes that result in a pyramidal shape. Other characteristics of this roof type include wide or deep overhangs and a large, hipped central dormer facing the front.

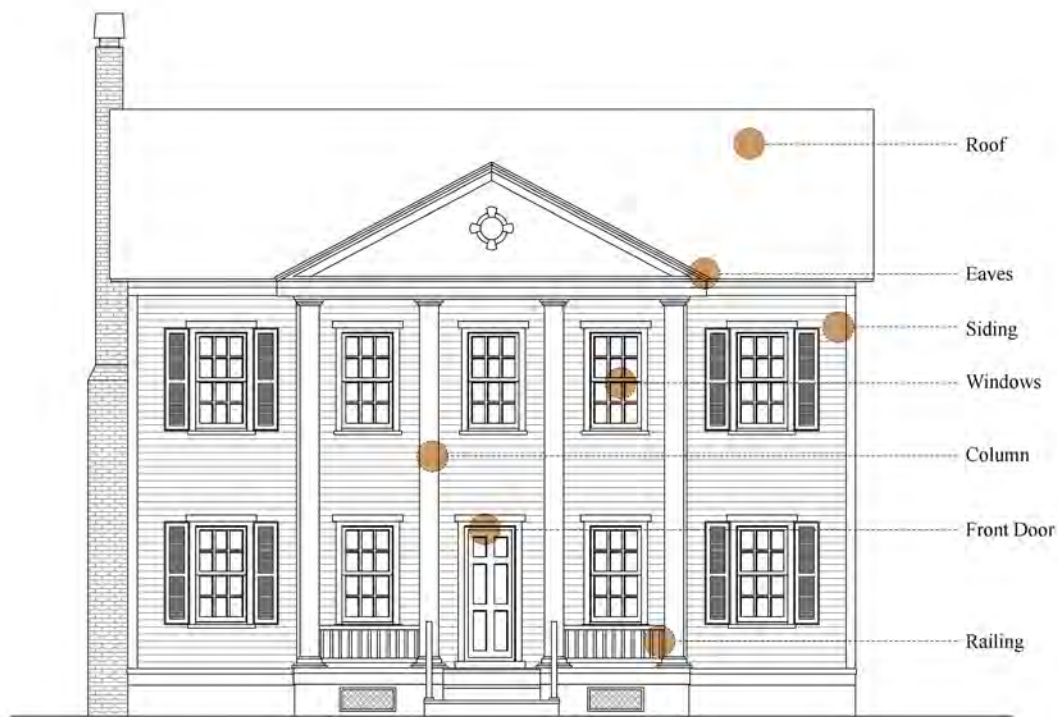
Figure 5.21: *Greek Revival Facade Features*

with a faux finish. The windows are mostly double hung with six panes to each sash. Decorative windows were frequently in three-part assemblages and among the style's unique features are the small rectangular windows set into the frieze beneath the cornice that replaced the common dormer. Window surrounds tended to be less elaborate than doorways. The doors, single or double, divided into one, two, or four panels, have elaborate surrounds with small-paned sidelights and a rectangular transom framed by heavy, wide trim, and sometimes recessed. The Greek Revival roof is typically a low-pitched gable with a hip. The cornice line is typically embellished with a wide band of trim to resemble a temple-like roof. The roof is covered with standing seam tin or cedar shingles.

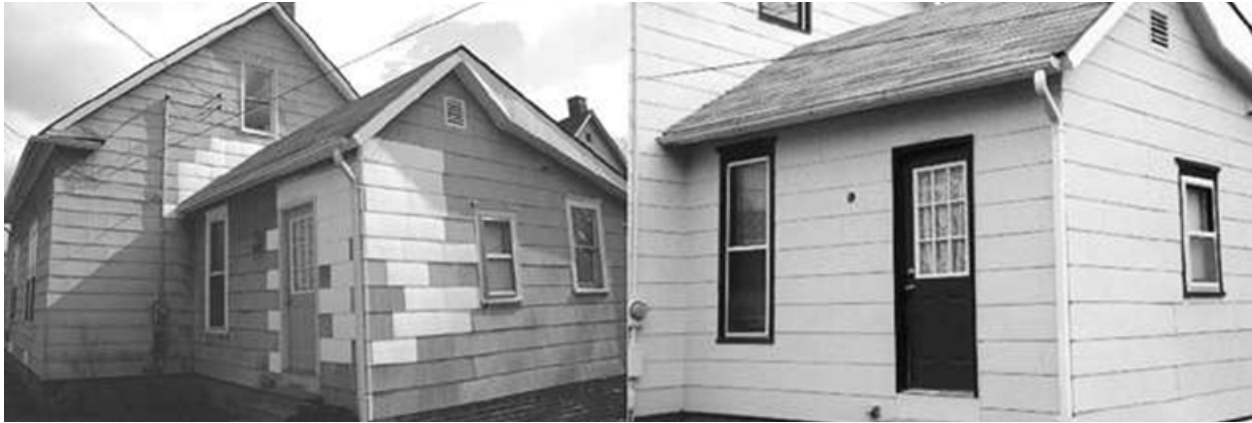
Figure 8.6: Replacement non-asbestos fiber-cement shingles in place, before being painted and after (photo by author).

Figure 8.6: *Replacement non-asbestos fiber-cement shingles in place, before being painted and after (photo by author).*
