DESIGN GUIDELINES FOR HISTORIC PROPERTIES

CITY OF LAKE LAND

Adopted (12/17/2020)

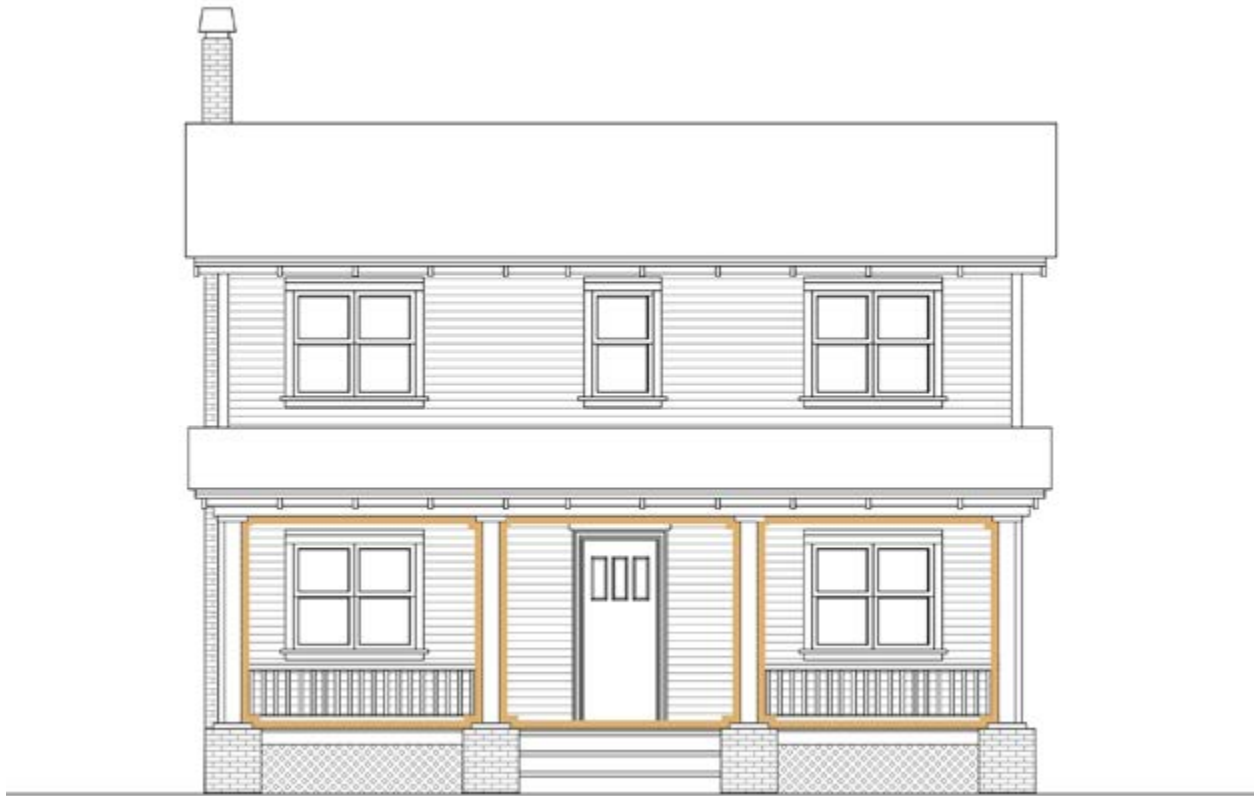
Figure 4.18: Regular Arrangement of Porch Columns and Wall Openings

The way columns are placed on a porch, fenestration patterns of windows and doors and other façade features defines the structure's perceived rhythm and order from the street. This layered condition, which often defines symmetrical facade conditions, is also one of the most prominent visual compositions that expresses a unique architectural style. New infill structures and porch additions should interpret these as precedent conditions and reflect porch column and fenestration patterns that work in conjunction with each other as major façade compositions.

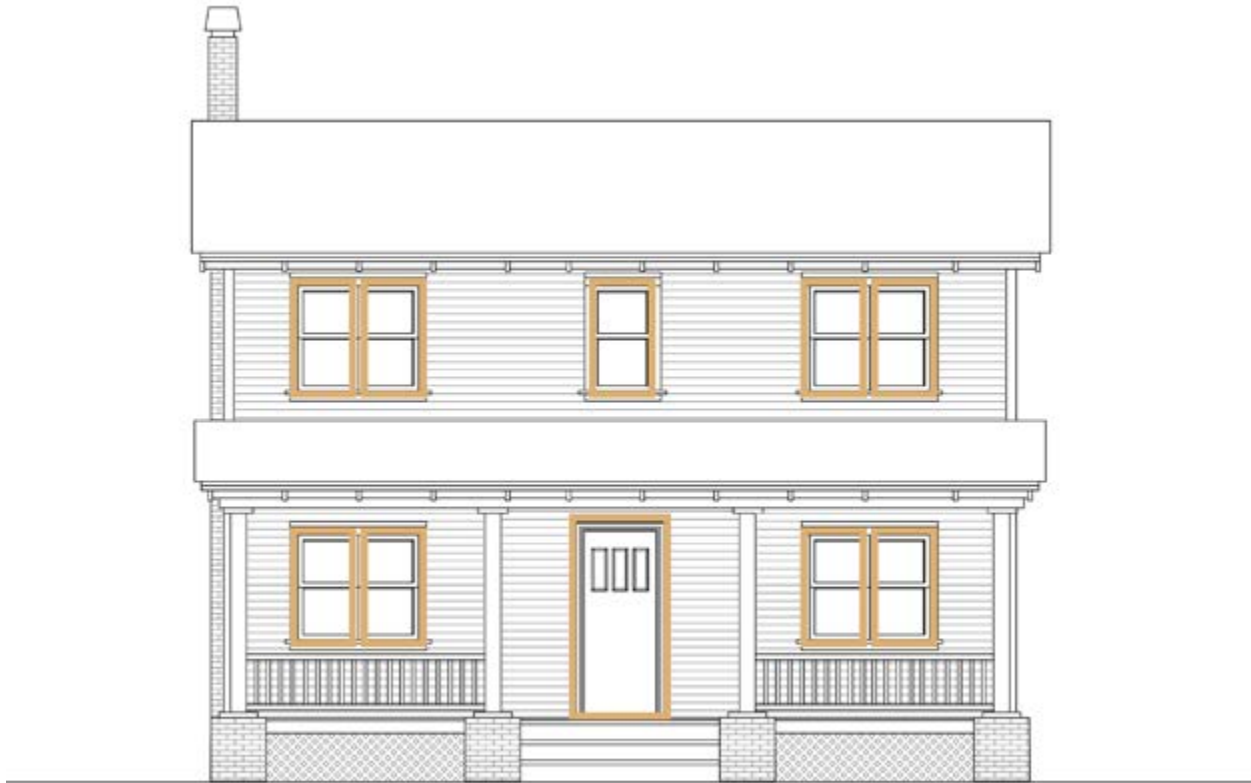
Figure 4.20: Acceptable Window Configurations

trim features. Windows should be configured vertically or square with height to width proportions ranging from 1:1 to 3:1. These proportions are often based on the human body and reflect the window patterns of adjacent historic structures. The many window options available today are primarily constructed of wood, clad-wood or a synthetic material such as vinyl. Regardless of materials used, windows in new infill structures that use traditional design features, should be indiscernible from wood windows at about four feet away.

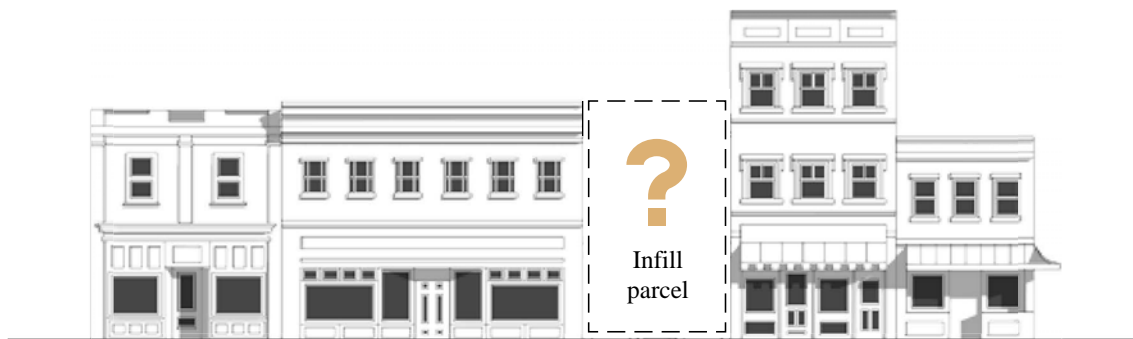
Figure 4.43: *Commercial Infill Conditions*

Infill development in commercial areas should be well-suited to historic contexts and should incorporate construction methods that relate to the current time period. While existing historic structures can serve as inspiration for new infill development, these Guidelines do not require a direct replication of existing historic buildings. Doing so creates a false sense of historicism and may in fact detract from the authentic character that already exists. However, with the construction of buildings over three stories in height, historic buildings over three stories in height should be referenced in designing new, taller structures.

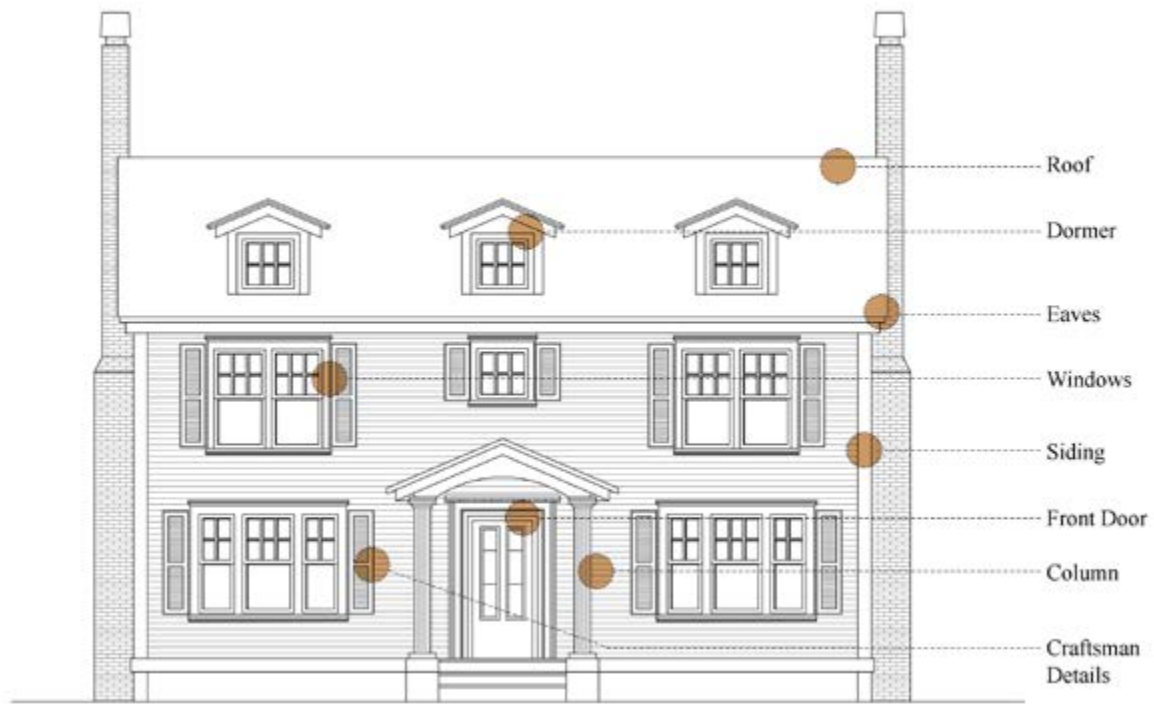
Figure 5.12: Colonial Revival Facade Features

historic structures, the Colonial Revival is supported by brick (earlier periods) or concrete (later periods) piers that are spaced out to allow for ventilation and for protection from high water. The exterior is typically made of horizontal wood siding and is decorated with pediments, broken pediments, and wood shutters. The doors have a simple classical trim and are often flanked by fixed glass sidelights. The windows have simple trims and are sometimes framed by wooden or wrought iron grills. The windows are paired double-hung wood sash with 6/6 or 2/2 divided panes. Colonial Revival either has a gable, hip, or gambrel primary roof with the porch roof being a shed or low-sloped configuration. Dormers with hip, gable or shed roofs are a defining characteristic with rafter ends typically exposed and decoratively cut. The roof is covered with composition shingles or occasionally metal roof coverings. All chimneys are brick with simple coursing, shoulder and corbel details.

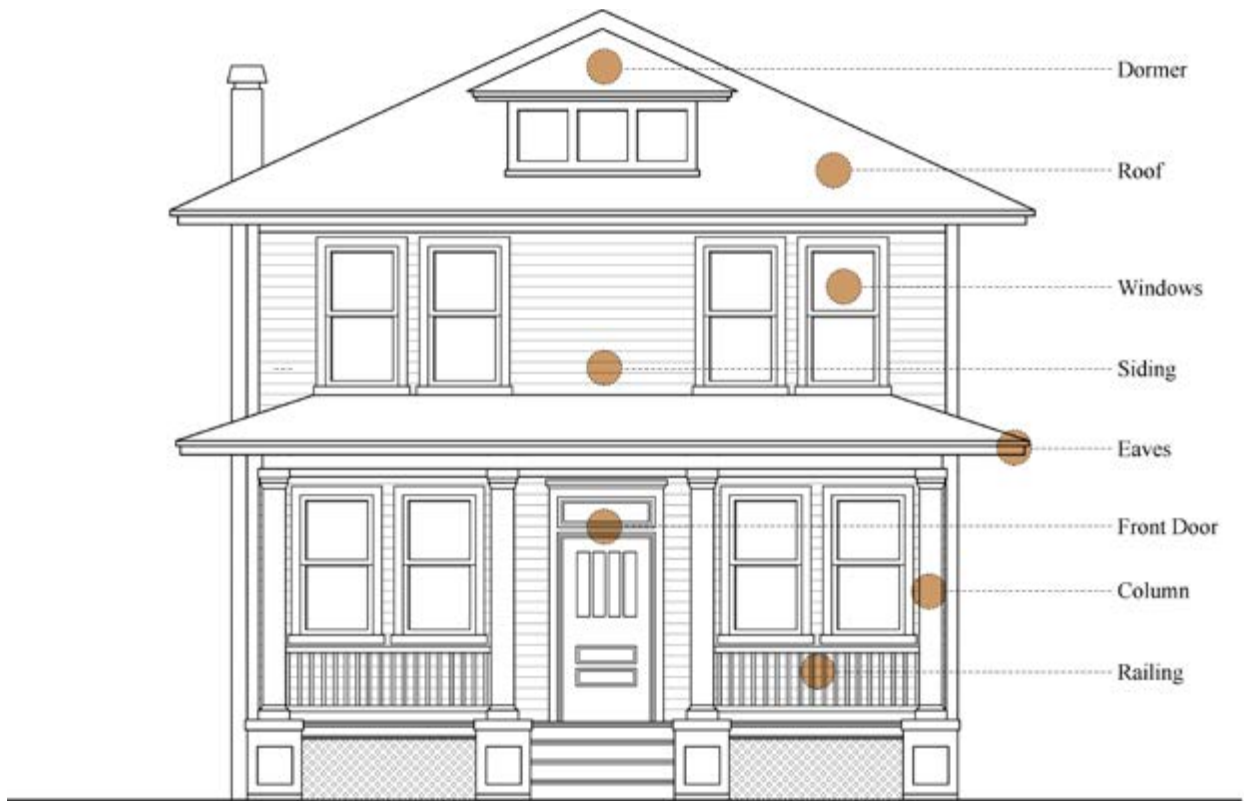
Figure 5.18: Four Square Facade Features

and for protection from high water. The Four Square has a symmetrical façade, sometimes with an offset porch. The porch is always accessed by wide entry stairs and runs the full width of the house with classical, rectangular columns under a hipped-roof with wide overhangs. The exterior can be found in many different materials and sometimes in combination of horizontal wood siding, brick, stone, stucco, shingle, clapboard siding. The house features simple, double-hung, often irregularly shaped windows with a sheet of plain glass for the lower portion and, a grouping of smaller panes united in a single frame divided by thin mullions for the upper portion. The roof configuration of the typical Four Square house is a combination of hipped planes that result in a pyramidal shape. Other characteristics of this roof type include wide or deep overhangs and a large, hipped central dormer facing the front.

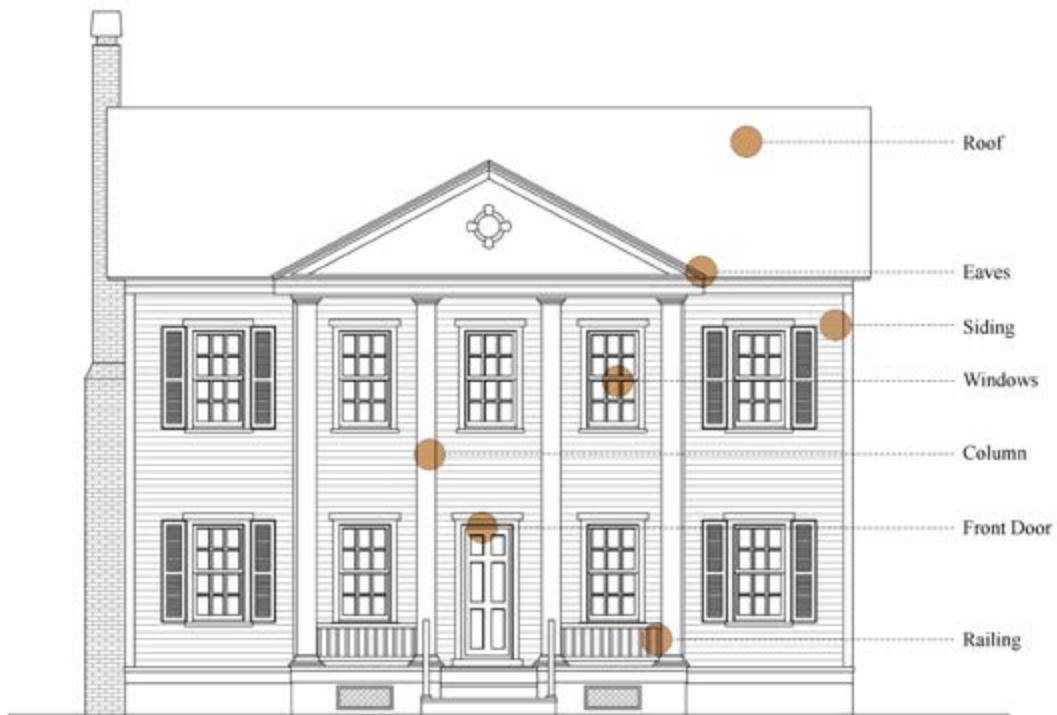
Figure 5.21: Greek Revival Facade Features

with a faux finish. The windows are mostly double hung with six panes to each sash. Decorative windows were frequently in three-part assemblages and among the style's unique features are the small rectangular windows set into the frieze beneath the cornice that replaced the common dormer. Window surrounds tended to be less elaborate than doorways. The doors, single or double, divided into one, two, or four panels, have elaborate surrounds with small-paned sidelights and a rectangular transom framed by heavy, wide trim, and sometimes recessed. The Greek Revival roof is typically a low-pitched gable with a hip. The cornice line is typically embellished with a wide band of trim to resemble a temple-like roof. The roof is covered with standing seam tin or cedar shingles.

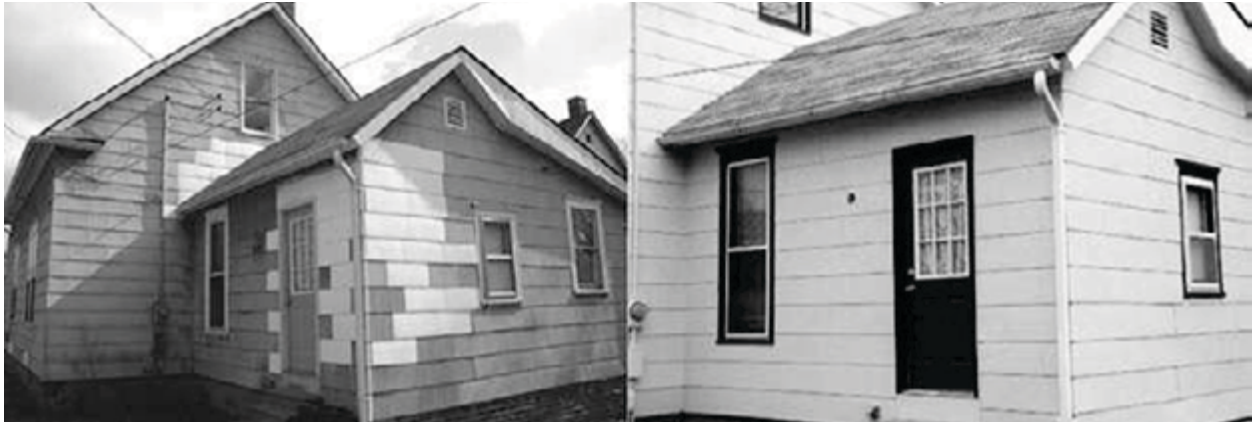
Figure 8.6: Replacement non-asbestos fiber-cement shingles in place, before being painted and after (photo by author).

Figure 8.6: *Replacement non-asbestos fiber-cement shingles in place, before being painted and after (photo by author).* **289**
